Manhole Inspection Summary

Manhole # S17K__025MH

Location Address: **2543 franklintown-alley-catherine**

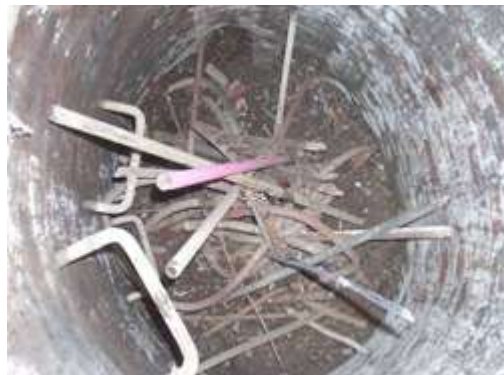
Top View

Condition: ☐ Sound ☐ Cracked ☐ Root Intrusion ☒ **Loose Brick** ☒ **Deteriorated**

Infiltration: ☐ None ☒ **Joint** ☐ Cracks ☐ Mortar ☐ Roots ☐ Wall
